Prevention of Undue Stress on Wiring Harness

The Contigo 6100 Wiring Harness connects the 6100 GPS Beacon to a vehicle's power, ground and ignition systems. Additionally, the harness provides the ability to monitor or control vehicle systems using input and output connections.

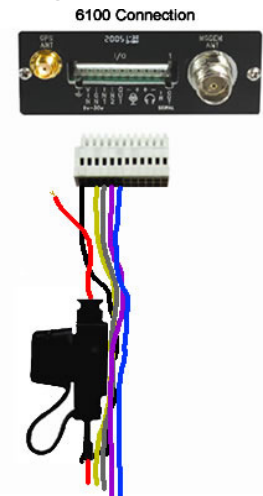
Figure 1

It has been reported that, very infrequently, the red power wire may become separated from the wiring harness connector that attaches the harness to the beacon. See Figure 1.

Contigo has determined that this **does not represent a safety risk** to the vehicle or its occupants. However in such an event, the beacon will lose power and cease operation. Should this occur, the **wiring harness must be repaired or replaced**.
